February 2, 2020

## **Tangent Scale Models B&O I-18 Caboose Coupler Box Fix**

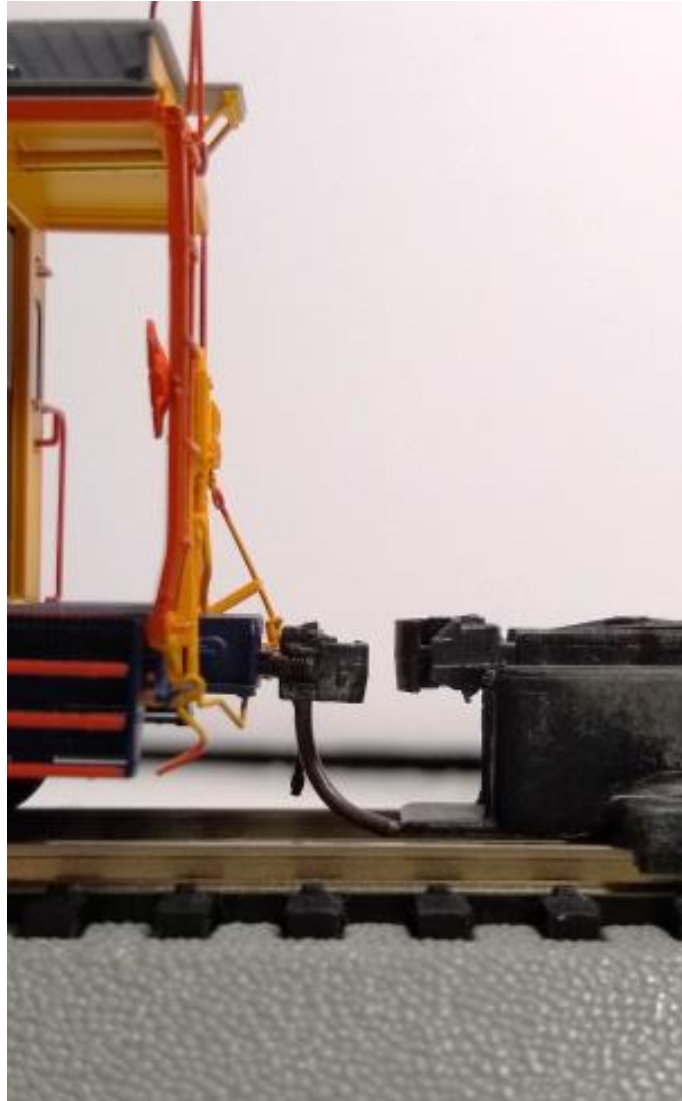
To our loyal customers: Thank you for your business with Tangent. A very small percentage of our new B&O cabooses sold have an issue with sagging draft gear. These are hand assembled cars and this issue is caused by an assembly issue during production. These repair steps take 5-10 minutes at most to complete. We apologize for this oversight.

Example of a caboose coupler that is too low:

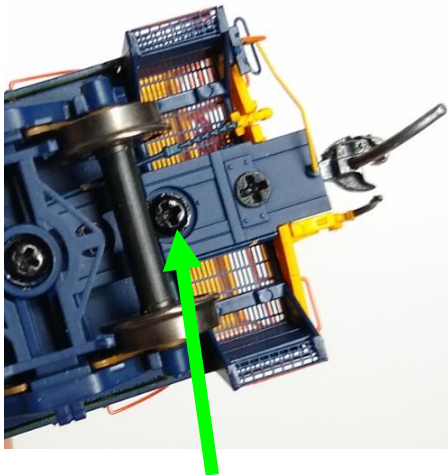
This is an assembly issue that can be fixed:

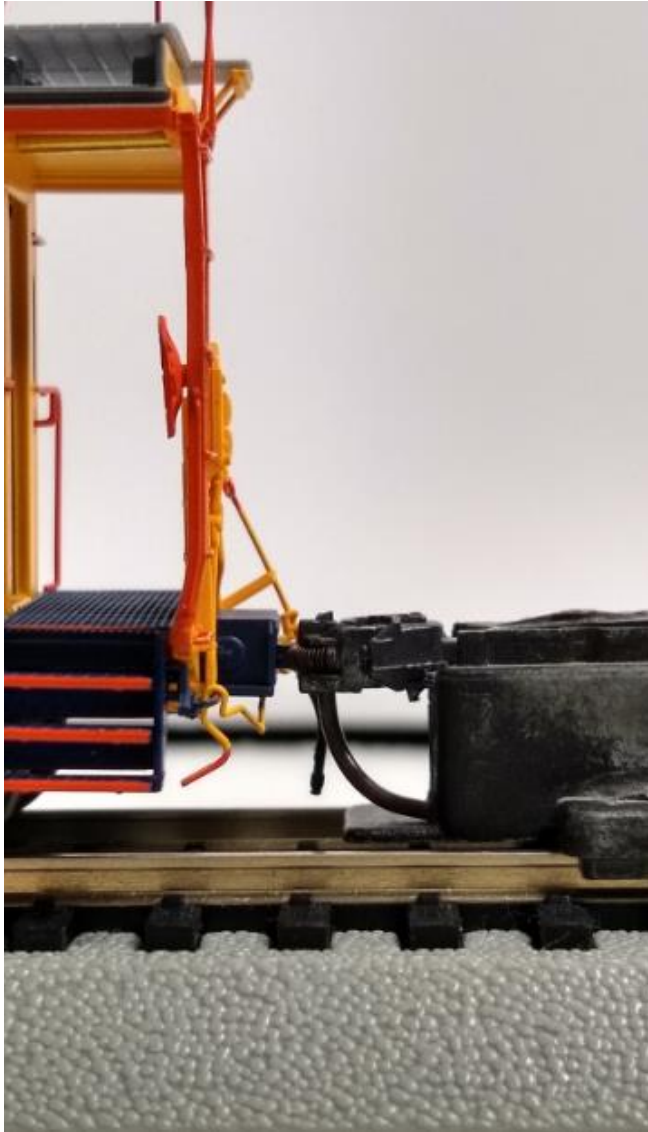
Now the coupler should rest at the correct height.
